## In-Place Stabilization of a Stone Masonry Facade

M. Schuller<sup>1</sup>, W. Ruth<sup>2</sup>

A 100-year old stone masonry facade was visibly displaced and in danger of collapse due to inadequate support, poor initial construction, moisture infiltration, and related freezing action. Rather than demolish and rebuild the facade, a scheme was developed for in-place stabilization using a combination of shoring, grout injection, and anchoring. A cementitious grout was used to fill internal voids and stabilize the facade and adjacent shear walls, followed by installation of a series of 1.6 m anchors tying the facade to the shear walls. Nondestructive testing, utilizing ultrasonic pulse velocity measurements, was used to characterize the masonry prior to the work and to verify the effect of grout injection following stabilization. This project demonstrates that severely damaged walls can be saved from demolition with the careful application of appropriate techniques and associated quality control testing.

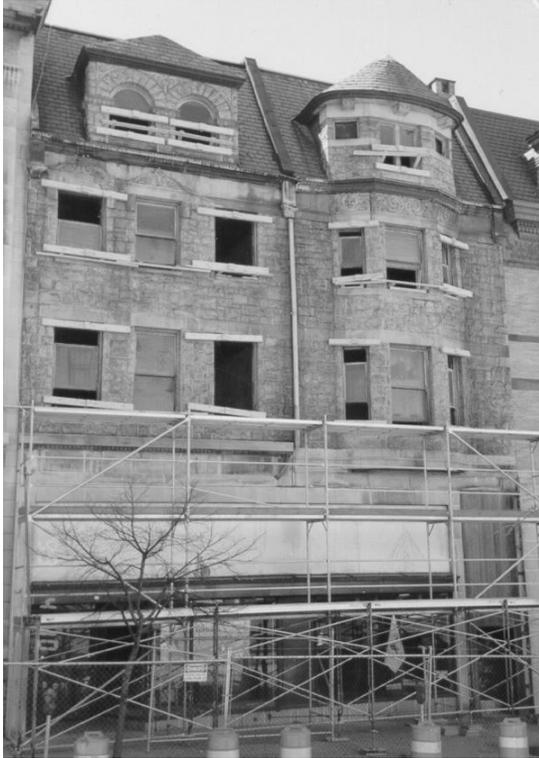
Figure 1. Street elevation of the building, showing the façade before stabilization.

The building was constructed in 1903 as two private residences and is being converted to modern office space. The façade is supported by steel beams at the second floor, installed several decades ago when the first floor masonry was removed in favor of a glass storefront. The supporting wall was modified several decades ago by removal of the first floor masonry and installation of a glass-panel storefront. A series of steel beams were added to support the facade and the bay window, which cantilevered out from the main wall section. Years of moisture infiltration, in combination with changes to the structure supporting the stone façade, led to deterioration of building materials. As a result, a 50 mm separation had opened up between the granite facing and the brick backup, with an additional separation of the façade from supporting masonry shear walls by up to 50 mm. By all indications, the stone facing was in danger of collapse and required emergency shoring and bracing. The historic nature of the building, beautiful stone façade, and costs associated with rebuilding the facade led to the recommendation that the stone be stabilized in place rather than demolished.

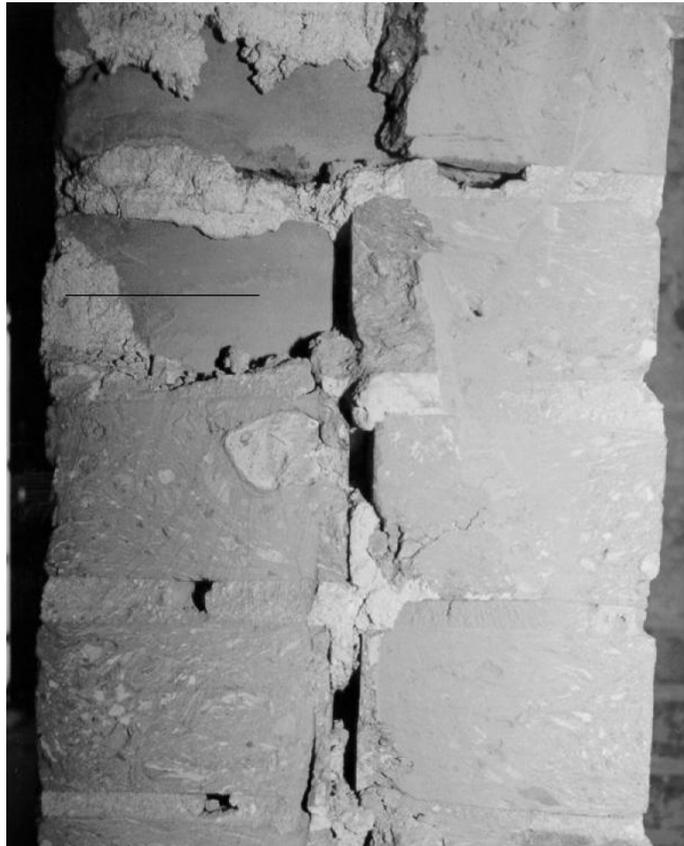
Brick were set in a lime-based mortar with poorly filled joints. The photograph in Figure 2 shows the typical internal wall construction. Observation of the wall interior was conducted using a borescope at 42 locations, verifying that walls were poorly constructed with many unfilled mortar joints. Many individual brick were actually loose within the wall and could be removed by hand.

Brick masonry was suffering from the effects of years of moisture infiltration. Water entered directly into masonry walls via a leaking roof gutter system, around window frames, and through roof leaks. A downspout which had been missing for years actually dumped water into the façade, exacerbating problems due to open mortar joints and poor roofing. The walls had many interior voids, as shown in Figure 2, that contributed directly to the

Figure 2. Typical section through interior shear walls, showing many internal voids and incompletely filled mortar joints. Interior voids were channeling water from gutter and roof leaks throughout the wall, resulting in mortar deterioration and related freezing damage.

masonry deterioration: once within the wall, water was able to travel within the large void network of unfilled internal mortar joints. The effect of the moisture infiltration was twofold: 1) deterioration of brick and mortar at the material level; and 2) freeze-thaw cycling, which successive increased separation of the stone facing from its brick backup. With portions of the rotting wood frames missing, visible displacement exceeding 12 cm were clearly seen, as well as additional movement of the granite's brick backup from the shear walls. A secondary deterioration pattern can be attributed to salt crystallization, and efflorescence was noted at some heavily deteriorated areas.

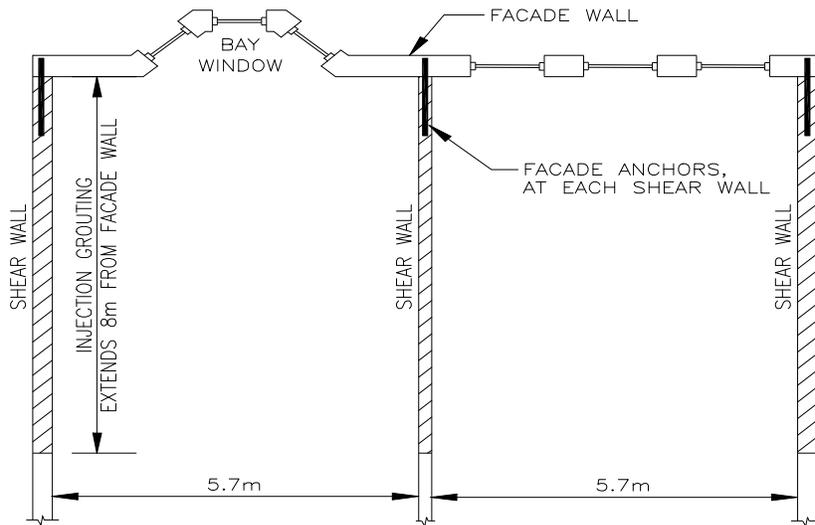
Figure 3. Building plan, showing injection areas at shear walls and façade anchors.

As shown in Figure 3, three cross walls comprised the main load-bearing structure of the building. These walls were an essential component of the stabilization scheme and were designated to function in two different capacities: 1) for attachment of temporary shoring to hold the facade in place during repairs; and 2) to provide anchorage through connection with the main facade wall. In their current condition, with many frequent internal voids and deteriorated masonry, masonry bearing walls did not possess the capacity for either role. The first step of repair implementation was enhancing the capacity of these walls to resist brace and facade loads. Injection of specially formulated cement-based grout into internal voids and fractures was specified to bond together wythes of the masonry wall system to better resist applied loads.

Shear walls were injected for a distance of 8 m from the facade wall, as shown in Figure 3. A large quantity of grout was required to complete the injection, and records of grout quantities injected showed that interior mortar joints ranged from 60 to 80 percent void. In the portions of the shear wall which were stabilized, several abandoned chimneys were located. These flues were isolated from the injection work, so that only the brick walls were filled.

A series of grouted anchors was used to connect the facade wall to adjacent shear walls. As shown in Figures 3 and 4, 21 total anchors were installed to tie the brick and stone facade to the newly injected shear walls. The anchors themselves were 16 mm diameter stainless steel rods, inserted into 38

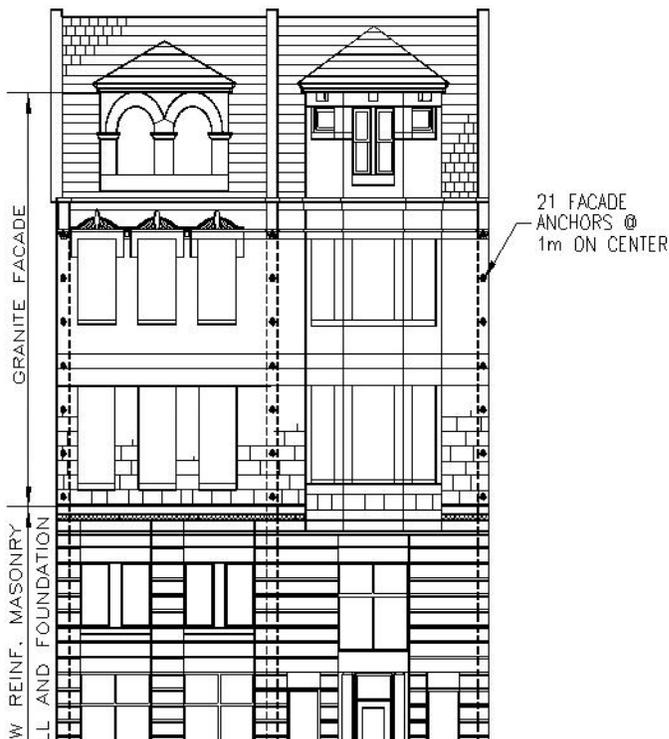
Figure 4. Building elevation. Three lines of grouted anchors were used to tie the façade to shear walls.

mm diameter holes cored 1.6 m into the walls. These anchors were placed in sequence, only after the shear walls and façade backup was stabilized, and the granite anchored back to the stabilized brick. Anchors were designed to carry loads from the facade resulting from wind and eccentricities in vertical load due to leaning of the walls. Embedment into the shear walls was longer than necessary, by a factor of about 2.5 times, to mobilize more of the shear wall mass to further anchor the facade wall and guard against future movement.

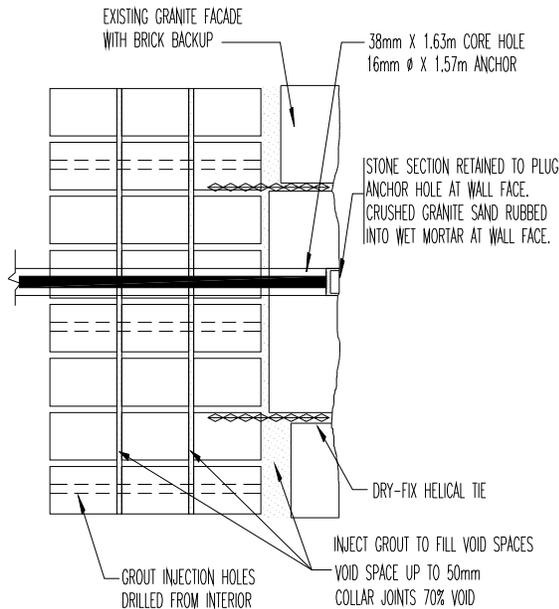
Figure 5. Façade section showing typical anchor and tie installation as well as injection of interior void spaces. Note the void space between the stone facing and brick backup, caused by inadequate structural support, years of moisture infiltration, and freeze-thaw cycling.

The stone facing itself was stabilized following anchorage of the facade wall. As shown in Figure 5, a gap of up to 50 mm had opened between the stone facing and its brick masonry backup due to long-term moisture infiltration and repeated freezing cycles. The facade wall was stabilized internally using a procedure combining pinning with grout injection, providing a mechanical tie as well as overall bonding to the brick backup. Six-mm diameter helical dry-fix ties, used to tie the stone to the brick backup, also served in a capacity to resist hydrostatic pressure that developed during grout injection. The ties were installed at a spacing of 30 cm on center in mortar bed joints between stones. Stones taller than 36 cm were also tied at mid-height of head joints.

Heavily deteriorated masonry was rebuilt at some areas, typically near the source of moisture entry at the top of walls and around window openings. Lugeon permeability testing again identified an internal void structure consisting of relatively large, well-connected spaces. Injection holes were drilled from the interior to intercept mortar joint voids in the brick backup as well as the space that had opened between the stone facing and the brick backup. Measurement of the total grout volume injected at the facade showed the main void space to average over 35 mm in width.

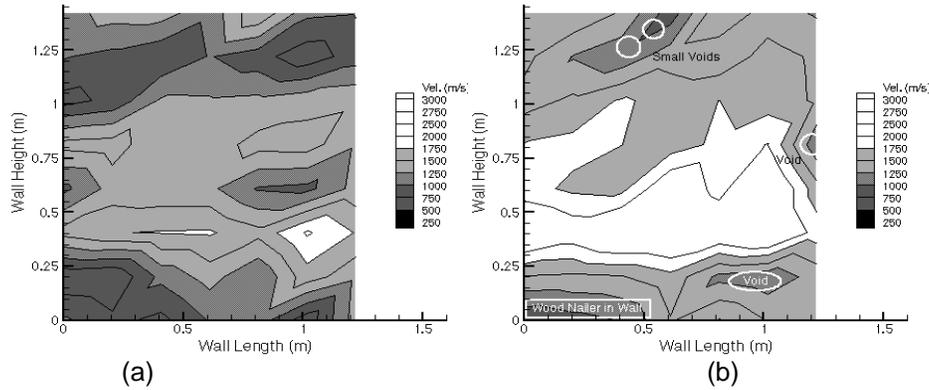
Following stabilization, wall solidity was measured using through-wall ultrasonic pulse velocity testing, conducted at the same locations as the pre-injection tests. Results of the pulse velocity testing, shown in Figures 6 and 7 as topographic velocity profiles, indicate an increase in wall solidity as measured by an overall velocity increase throughout the test areas.

Figure 6. Through-wall pulse velocity tests conducted on a wall panel at the 3<sup>rd</sup> floor. a) pre-repair and b) post-repair. Grout injection repairs increased the overall velocity. Note the 4 locations where low velocities identified voids within the wall. These areas were subsequently re-injected.

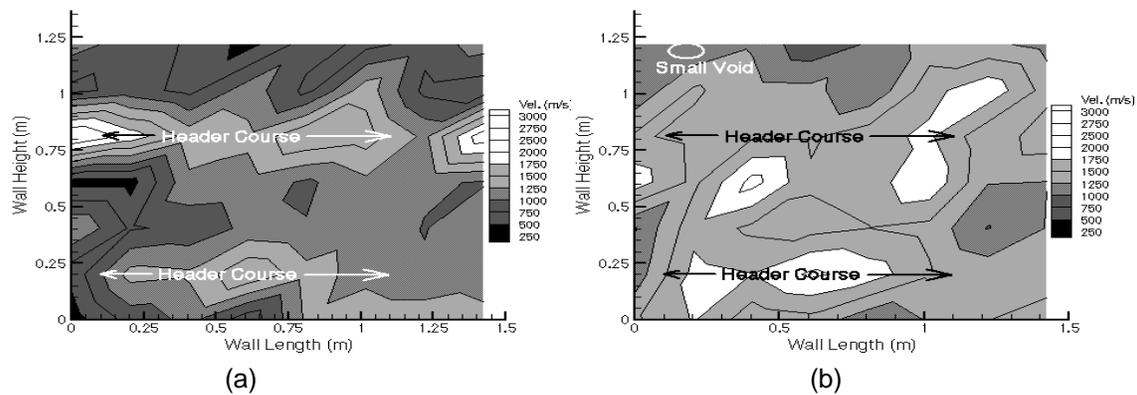
Figure 7. Through-wall pulse velocity tests conducted on a wall panel at the 4<sup>th</sup> floor. a) pre-repair and b) post-repair. Header courses, which showed as regions of higher velocity before the repair, were indistinguishable from surrounding masonry after internal voids were filled by grout injection. The isolated lower velocity regions after injection, shown in (b), were mainly attributed to individual brick that were deteriorated. One small void was verified with the borescope, as shown, and re-injected.
