PROJECT DATA SHEET:

43 MacDougal Street

ANSWERING A COMMUNITY'S CALL FOR HISTORIC PRESERVATION

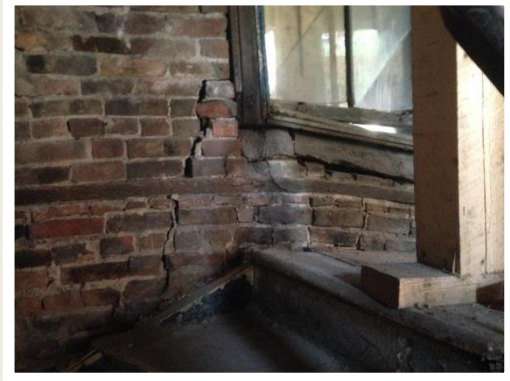
Pre-Injection

- Lime based mortar had severely deteriorated in both the visible mortar joints and collar joints inside of the wall to the point where the mortar was like sand
- Building façade plane continued to the neighboring property causing facades to separate from the party wall
- The masonry shell was in such bad condition that project members expressed concerns over a possible collapse

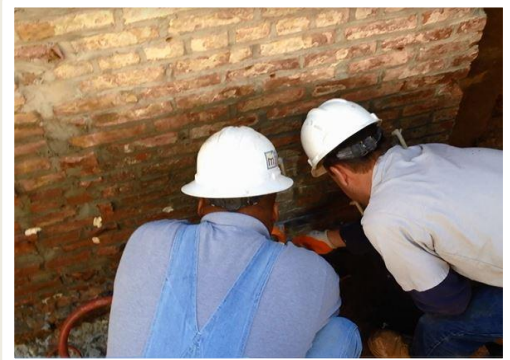
Post-Injection

- Further NDE demonstrated the solidity of the masonry units, thus confirming stabilization of 43 MacDougal's facades
- The neighboring community and preservation advocates everywhere could breathe a sigh of relief knowing this valuable piece of history was now in stable condition

- Masonry Solutions laboratory engineers then determined a compatible injection material that was sympathetic to the host's particular characteristics
- Façade walls were partially shored to prevent any movement and two entire facades were injected using low pressure Injection
