PROJECT DATA SHEET:
Colonial Williamsburg - Benjamin Powell Smokehouse

**PROVIDING A UNIQUE SOLUTION FOR ONE OF WILLIAMSBURG’S ORIGINAL
COLONIAL PROPERTIES**

Colonial Williamsburg – Benjamin Powell Smokehouse

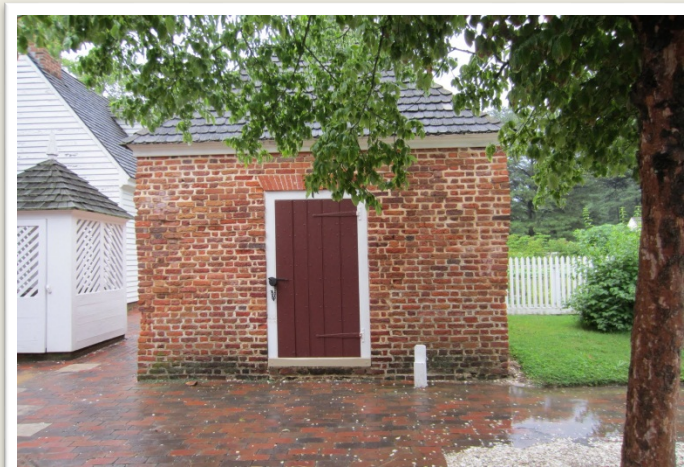
- The smokehouse had suffered severe deterioration of both brick and mortar due to salt crystallization within its walls and was unstable
- Local birds were actually eating the salts from the exterior walls, further damaging the structure
- Mortar deterioration was so severe that repointing of the mortar joints was required almost semi-annually
- Due to the irregular patterns and rate of deterioration, architectural conservators were hesitant to implement conservation measures without a clear understanding of the underlying processes taking place and their effects

- Masonry Solutions' laboratory engineers began by using non-destructive evaluation techniques, including ultrasonic and mechanical pulse velocity surveys and infrared thermography scans to study the structure

- Pulse velocity surveys indicated severe internal deterioration not visible by other means
- MSI personnel utilized their findings to develop a unique poultice treatment that would remove salts from the interior walls

- Masonry Solutions formulated a CIF mix that would match the characteristics of its historic host
- This CIF mix was injected under very low pressure to ensure the walls were solidified and provided monolithic performance
