**PROJECT DATA SHEET:**  
**American Urological Association Headquarters**

**PRESERVING A BUILDING 'BEYOND REPAIR'**

## American Urological Association HQ

**Key Topics:** Façade repair, historic stabilization, moisture infiltration NDE, CIF injection

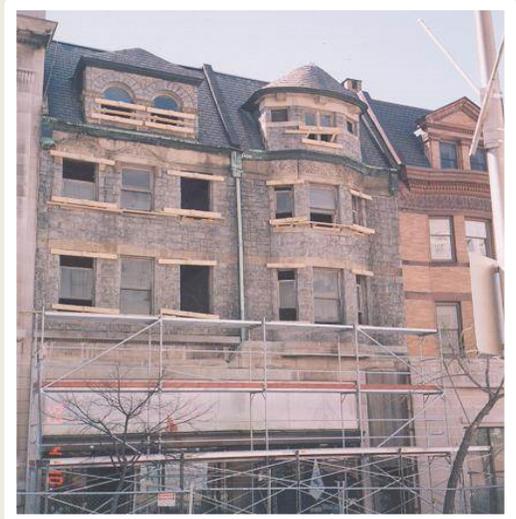
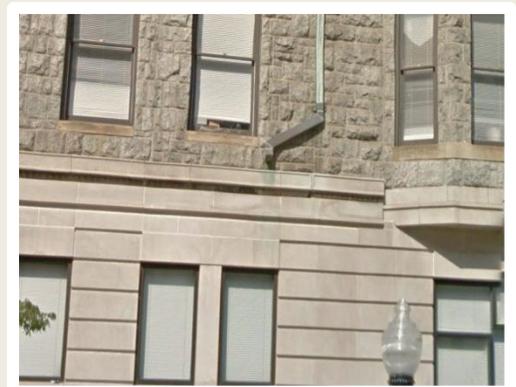
- During the renovation, the project team realized that the front façade was severely separated from the shear walls
- The situation was attributed to over a century of freeze thaw ratcheting, modifications, and moisture infiltration
- In certain areas the masonry façade was more than 11 inches out-of-plumb!
- The demising and adjacent walls were in poor condition as well, with their masonry units lacking any significant bond to each other due to mortar deterioration
- The project team was heavily considering demolition due to the building's rapidly worsening structural condition and associated safety concerns
