PROJECT DATA SHEET: The United States Post Office and Courthouse

PROTECTING A MASSIVE NEW YORK CITY LANDMARK

The US Post Office and Courthouse

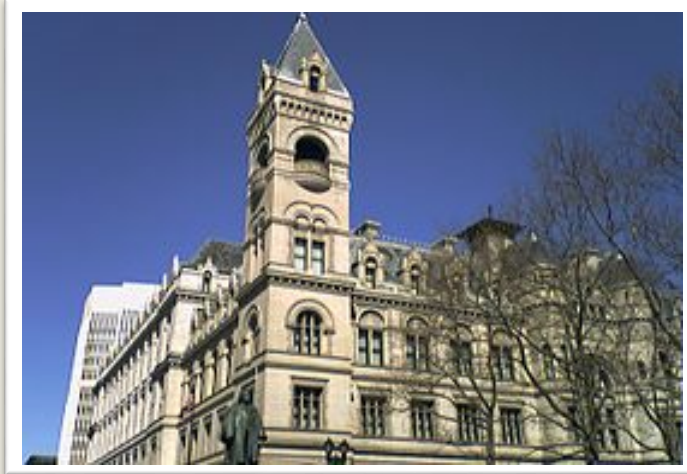
Location: Brooklyn, NY

Age: Built 1885

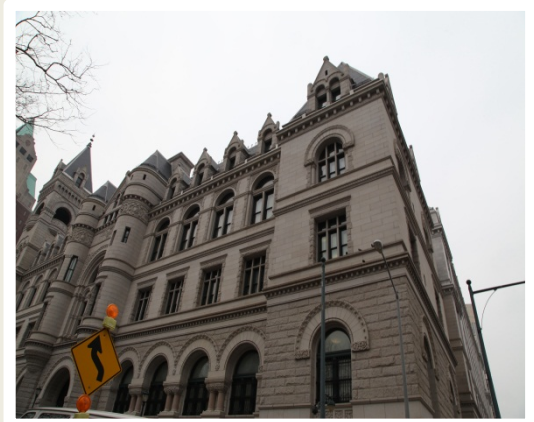
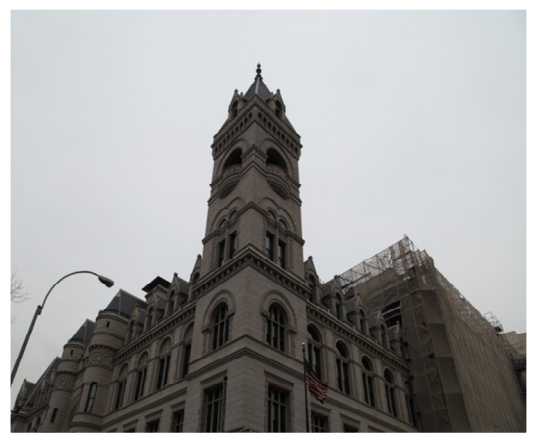
- As part of an award winning 10 year renovation program, GSA intended to develop the US Post Office and Courthouse into a base of various federal operations
- During the renovation program, project designers determined that the building's main feature, its 1885 tower, was unstable and could possibly collapse
- The cantilevered section of the tower's masonry was moving, and without proper intervention was at risk
- The granite walls along the area had a series of large voids and mortar joints cracking do to shifting stones

- Masonry Solutions International was contracted to perform an analysis of the situation and implement a program to stabilize the historic tower
- The tower interior had a newly laid masonry wall, but a series of voids were left behind the addition

- NDE aided MSI technicians in locating these void patterns, allowing them to target the critically affected areas
- Masonry Solutions determined that the four corners in the base of the tower would need stabilization and the granite sections just below the roof would need to be immobilized to prevent future shifting
