Internal Strengthening of Historic Clay Brick Masonry Pump Houses in New Orleans

ABSTRACT

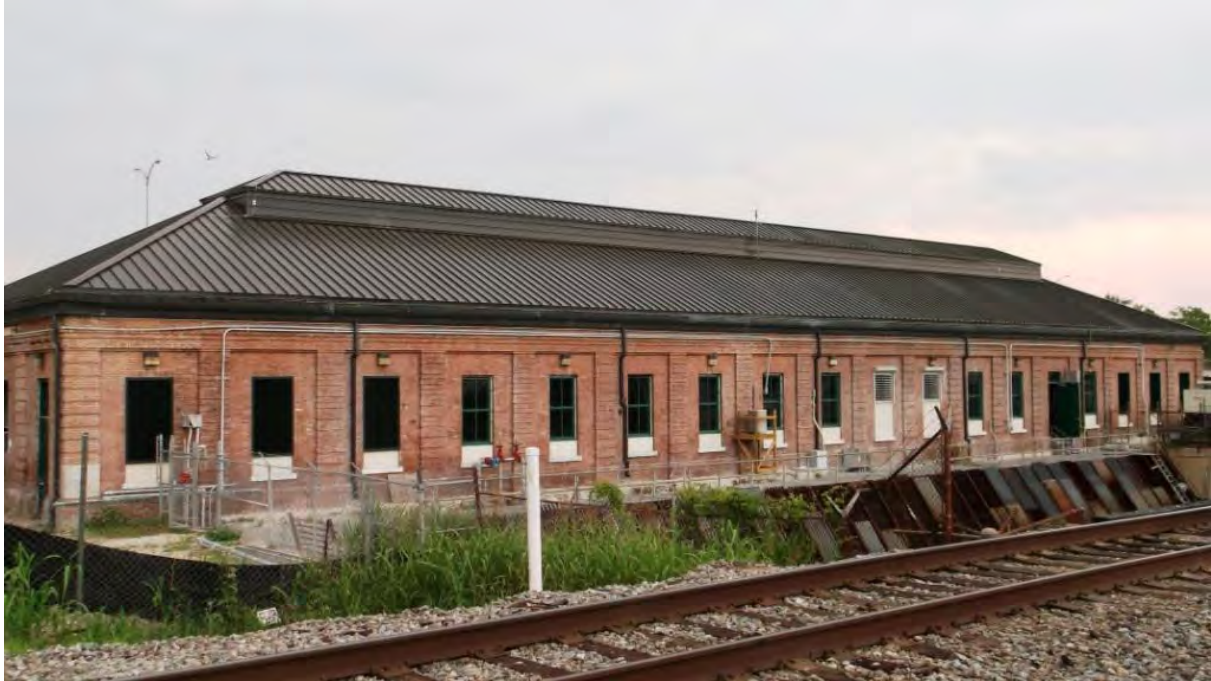
Fig. 2 Overall view of typical Drainage Pump Station. Pump Station 7 is shown here.

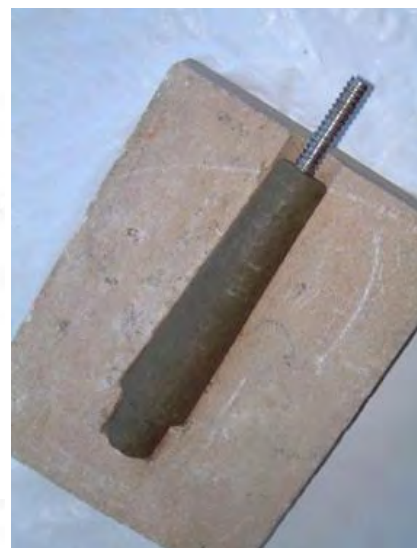
Fig. 5 Left, design detail showing the reverse tapered vertical reinforcing termination. Right, installed taper.

The final retrofit strengthening design included several components. As mentioned previously, the existing masonry wythes were tied together using stainless steel helical rods and injected solid with CIF. The masonry walls were also strengthened internally using vertical stainless steel reinforcing bars (Fig. 6). These bars were installed into holes that were cored from the top of the wall into the foundation using specialty coring equipment. Since development of the vertical reinforcing at the base of the wall was sometimes critical to the strengthening design, a special end detail was used to engage the reinforcing into the foundations. The bottoms of core holes were reverse tapered, and the bars were installed with a washer and sock at the base (). This connection provided a positive, mechanical attachment to the foundations that is significantly more effective than adhesive bonding of the reinforcing alone. The stainless steel reinforcing was comprised of bars with a hollow core that permitted relatively simple filling of the sock at the taper with CIF material.

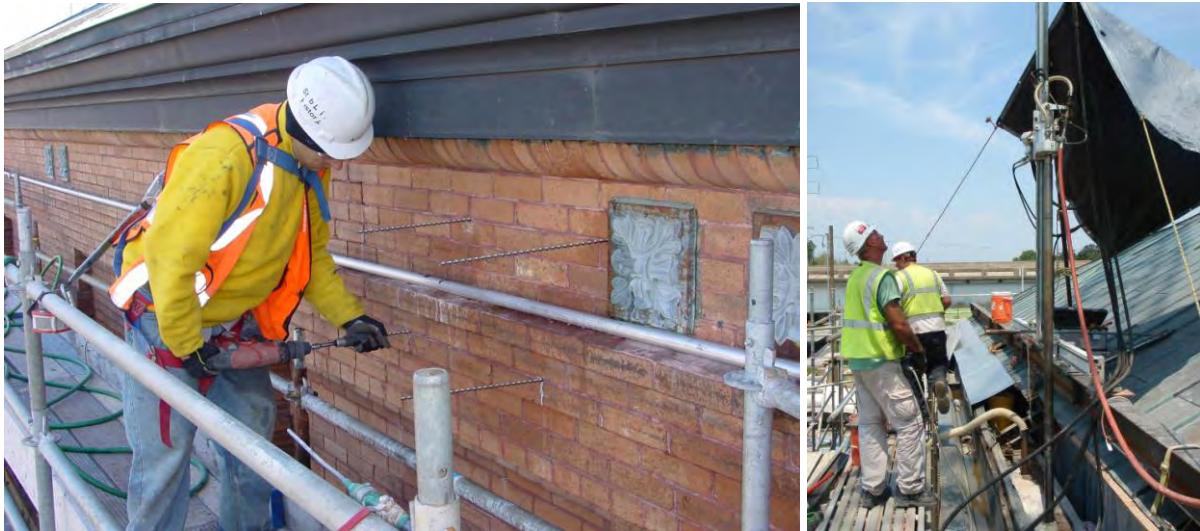
Fig. 6 At left, installation of helical wall ties into existing clay brick masonry walls. At right, coring at the top of the exterior walls in order to insert vertical reinforcing.

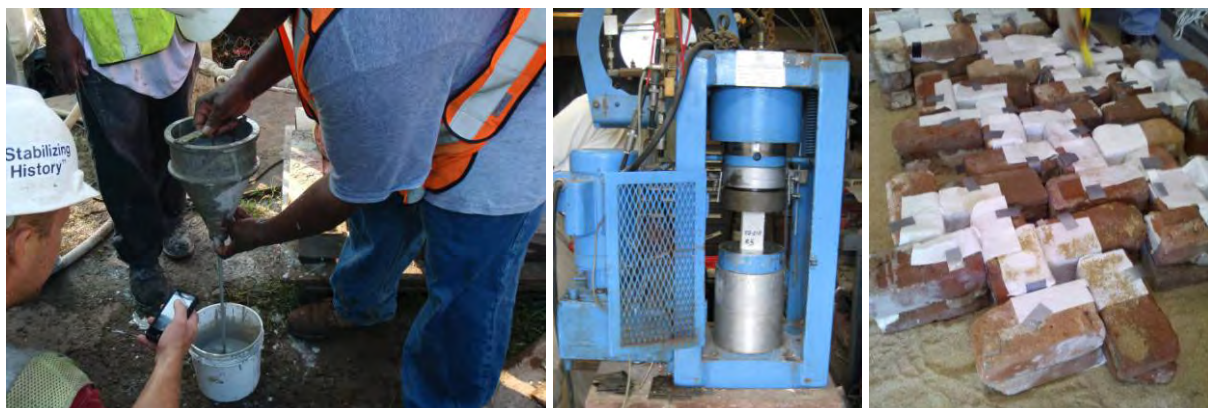
Fig. 8 Left, flow cone testing to verify viscosity of CIF material. Center, compression testing of a hardened CIF sample. Right, brick forms used to cast CIF compression samples.

In order to help ensure the quality of the CIF materials and installation during construction, numerous site and laboratory tests were conducted. The CIF material was sampled both from the batch plant and from the site and tested for compressive strength and vapor transmission properties. Wet material property tests such as bleeding and expansion testing were performed on the batch plant samples. Twice daily field tests were conducted to ensure proper flow of the CIF material (Fig. 8), and wet material density was also tested twice daily.

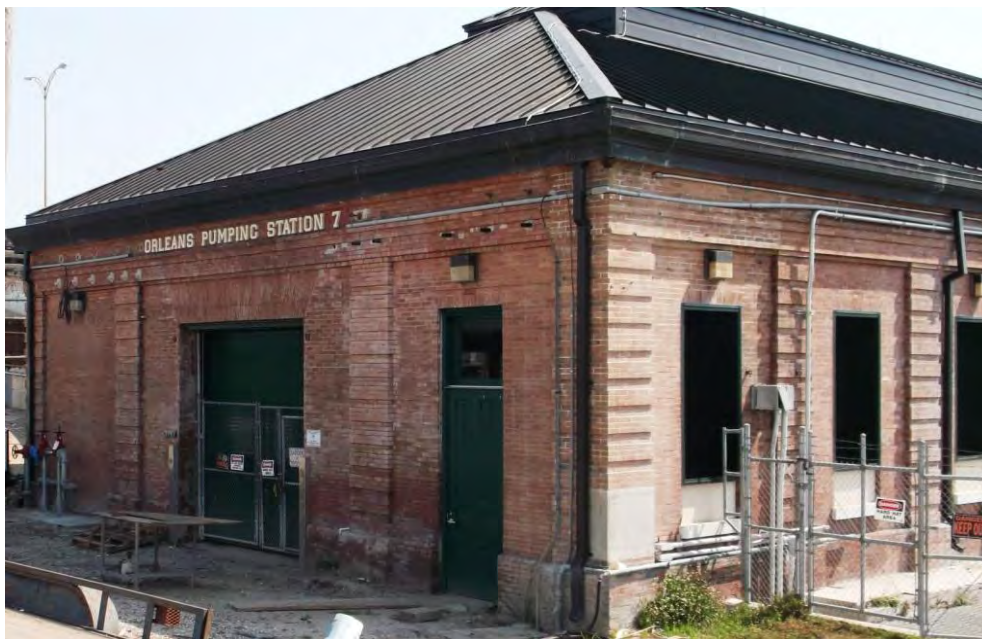
Fig. 9 Overall view of southwest corner of Drainage Pump Station Number 7 showing the clay brick masonry exterior walls after completion of the strengthening project.

Although retrofit work is on-going at several structures, the work at Pump Station 7 has been completed (Fig. 9). This pump station includes approximately 11,000 sq. ft. (1050 sq. m) of wall area, typically approximately 18 inches (460 mm) thick. Into these walls, approximately 42 cu. yd. (32 cu m) of CIF grout was injected (approximately 7% of the wall volume) to fill voids. A total of approximately 9000 linear feet (2700 m) of vertical stainless steel reinforcing bars were installed.

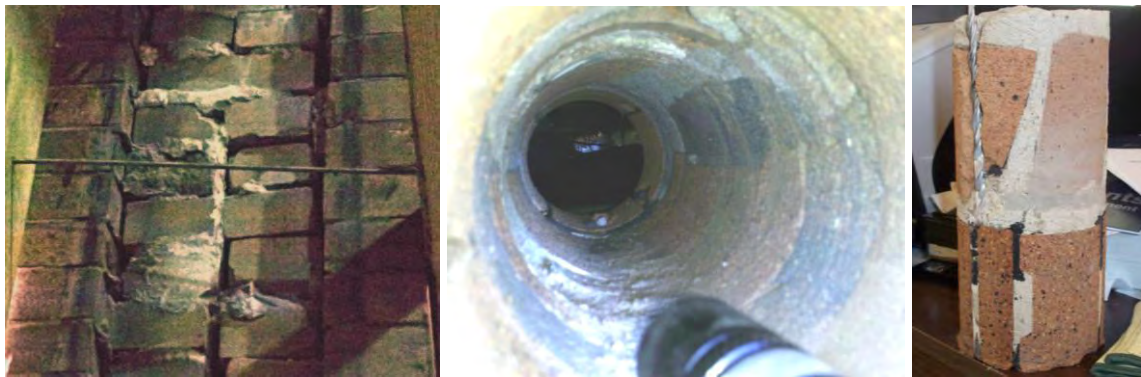
Fig. 10 Left, view of voids in brick masonry prior to injection at window jamb. Middle, view looking into a core hole made after completion of CIF injection showing the lighter colored CIF material has filled the voids in the wall. Right, core extracted from the exterior wall by the electrician after completion of CIF injection showing a helical wall tie and filled voids.

After completion at Pump Station 7, the structural enhancement appears to be successful. The walls have been grouted solid, and this has been confirmed using ground penetrating radar (GPR), borescope observations, and even subsequent coring through walls by electricians (Fig. 10). The vertical reinforcing was installed successfully using the reverse tapered end connections, and helical wall ties were installed throughout the masonry exterior.
