## **PROJECT DATA SHEET: West Point Academy – Mahan Hall**

**A LOOK AT MOISTURE PREVENTION AND SEISMIC RETROFIT FOR ONE OF THE  
WORLD'S MOST FAMOUS MILITARY INSTITUTIONS**

## West Point Academy – Mahan Hall

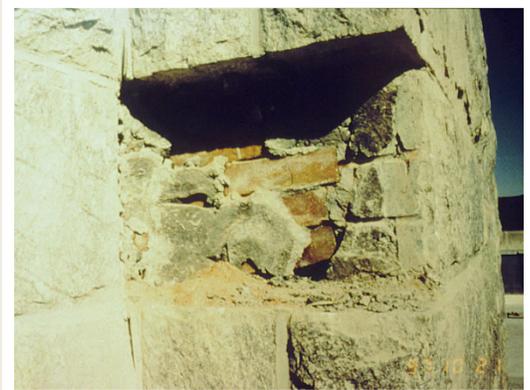
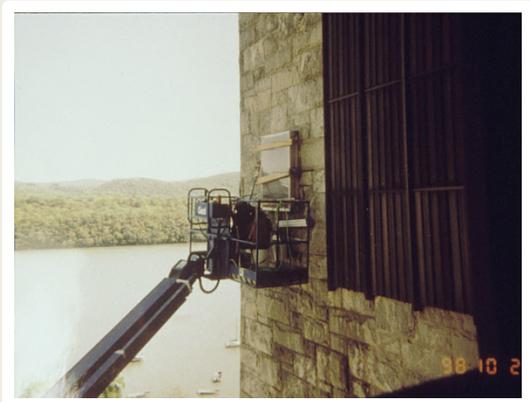
*CIF fines sealing moisture penetration path from the inside out*

- MSI's custom CIF needed to not only solidify voids, but also seep through the wall's cracks that were promoting water permeation
- MSI injection specialists then injected the exterior granite sections with their customized CIF. All of this work took place from interior brick walls as scaffolding the building's exterior for access was near to impossible

- CIF injection simultaneously strengthened the walls, prevented access for water infiltration, and allowed the building to meet the area's new seismic guidelines
