PROJECT DATA SHEET:

43 MacDougal Street

ANSWERING A COMMUNITY'S CALL FOR HISTORIC PRESERVATION

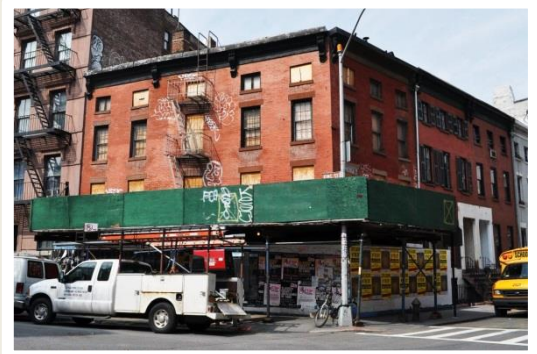
- Lime based mortar had severely deteriorated in both the visible mortar joints and collar joints inside of the wall to the point where the mortar was like sand
- Building façade plane continued to the neighboring property causing facades to separate from the party wall
- The masonry shell was in such bad condition that project members expressed concerns over a possible collapse

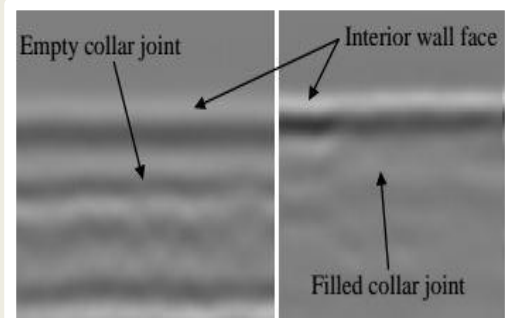
- Further NDE demonstrated the solidity of the masonry units, thus confirming stabilization of 43 MacDougal's facades
- The neighboring community and preservation advocates everywhere could breathe a sigh of relief knowing this valuable piece of history was now in stable condition

Pre-Injection

Post-Injection

- Masonry Solutions laboratory engineers then determined a compatible injection material that was sympathetic to the host's particular characteristics
- Façade walls were partially shored to prevent any movement and two entire facades were injected using low pressure Injection
