PROJECT DATA SHEET:
St. Patrick's Church

BOLSTERING ONE OF THE COUNTRY'S MOST HISTORIC CHURCHES

Location: New Orleans, LA

Age: Built 1840

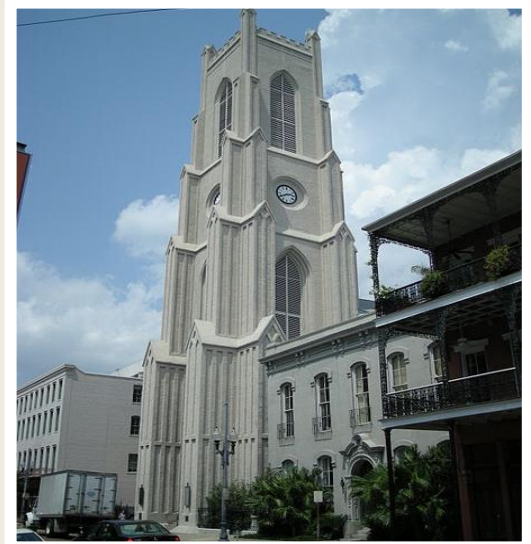
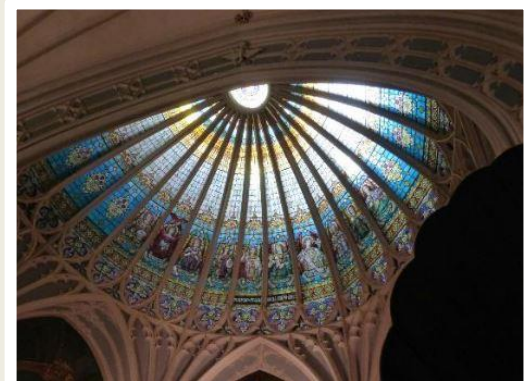
Repair and enhance without changing the aesthetics.

- The design team determined the best course of action was the strategic anchoring, pinning and compatible injection of the foundations' masonry units so that movement within the structure could be arrested

- MSI furnished over one thousand Stainless Steel 3/4" OD GRUENSTARK Hollow Injection Anchors.
- MSI techs carefully drilled through the fragile masonry and installed these specialized reinforcements into the foundation footings.

- Stainless steel helical wall ties were installed by MSI techs prior to injection in order to provide lateral reinforcement
- The walls' wythes were then effectively bonded together (and the anchors / ties mobilized) through the low-pressure injection of over 65,000 lbs of Compatible Injected Fill (CIF)
